**Part No: CEP-1126****Description: piezo audio transducer****Date: 9/25/2006****Unit: mm****Page No: 1 of 5**

## Specifications

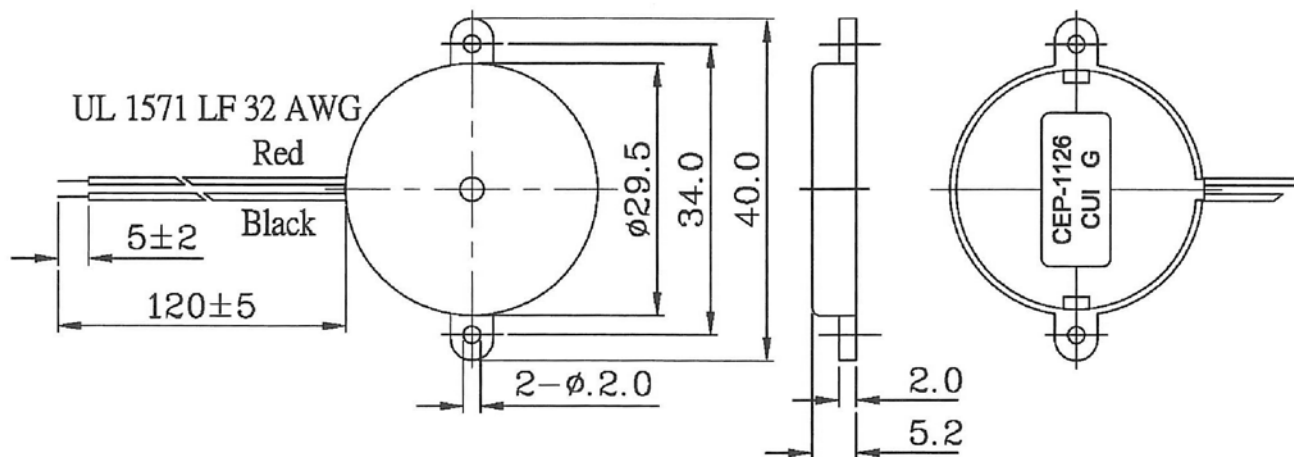
## Appearance Drawing

Tolerance:  $\pm 0.5$

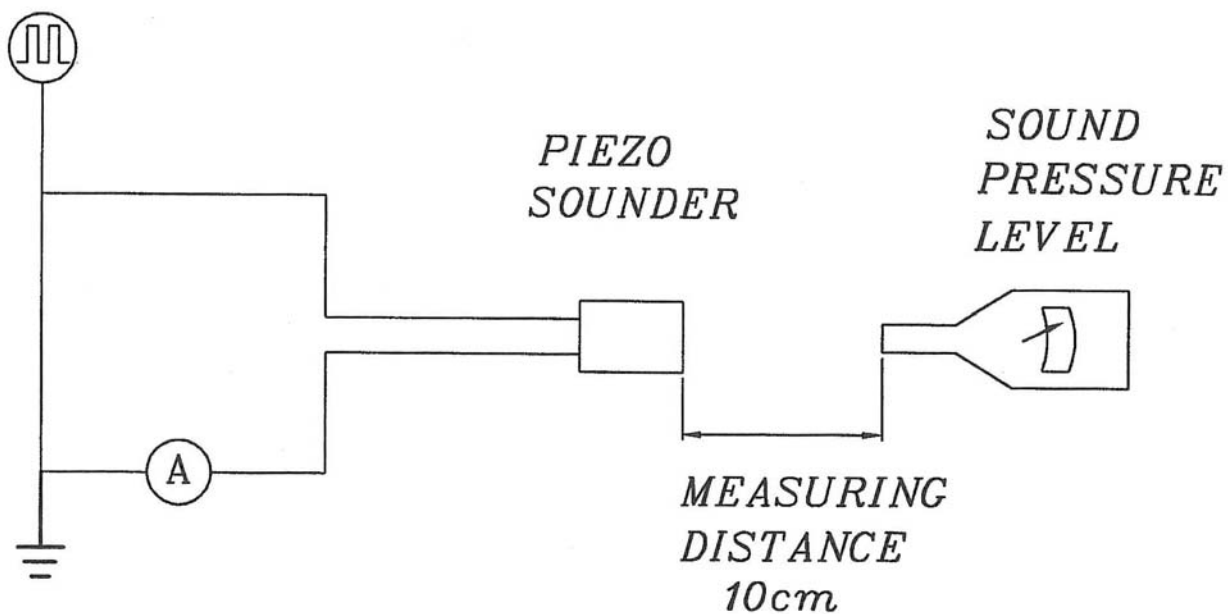
## Measurement Method

S.P.L. Measuring Circuit

Input Signal: 10 V p-p, 2.8 KHz, Square Wave

Mic: RION UC 30

S.G.: Hewlett Packard 33120A Function Generator or equivalent

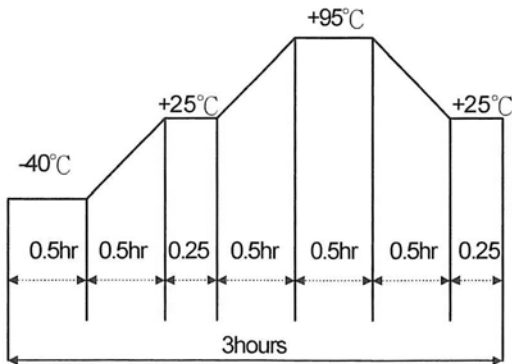
Item	Test Condition	Evaluation Standard
High temp. test	After being placed in a chamber at $+95^{\circ}\text{C}$ for 240 hours.	The buzzer will be measured after being placed at $+25^{\circ}\text{C}$ for 4 hours. The value of the oscillation frequency/current consumption should be $\pm 10\%$ compared to the initial measurements. The SPL should be within $\pm 10\text{dB}$ compared to the initial measurements.
Low temp. test	After being placed in a chamber at $-40^{\circ}\text{C}$ for 240 hours.	
Humidity test	After being placed in a chamber at $+40^{\circ}\text{C}$ and $90 \pm 5\%$ relative humidity for 240 hours.	
Temp. cycle test	The part shall be subjected to 5 cycles. One cycle will consist of:
